Survival Factors

Airbag Safety Study Factual Report

Location: Athens, TX
Aircraft Type: Cessna T182T
Accident Date: 2/27/2007
Accident Time: 1506 CDT
Accident Number: DFW07LA078
Registration Number: N14685
Airbag Equipped: Yes

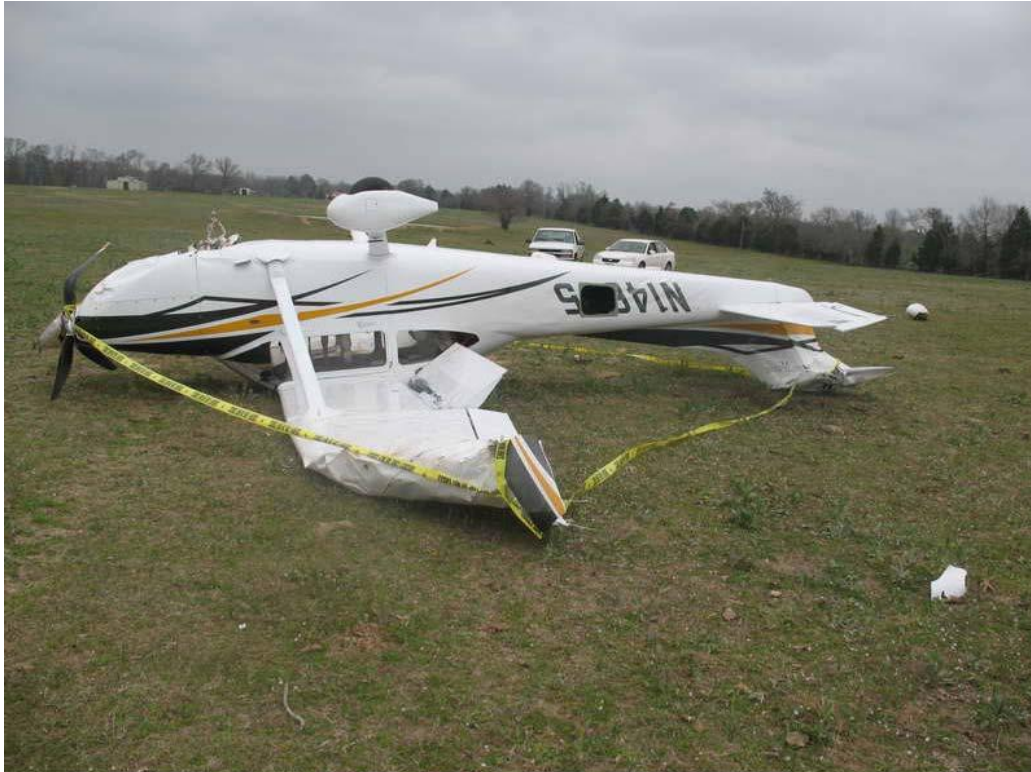
airplane nosed-over, coming to rest in an inverted position (see figures 1 and 2). The pilot stated that he unfastened his seatbelt, fell onto the ceiling of the airplane, and slid out onto the wing on his back. The pilot also stated that the front left seat passenger and rear left seat passenger were able to release their seatbelts easily¹ and that they exited the airplane through the left door.

Figure 1: A photograph showing the right side of Cessna T182T, N14685, which crashed in Athens, Texas (DFW07LA078).

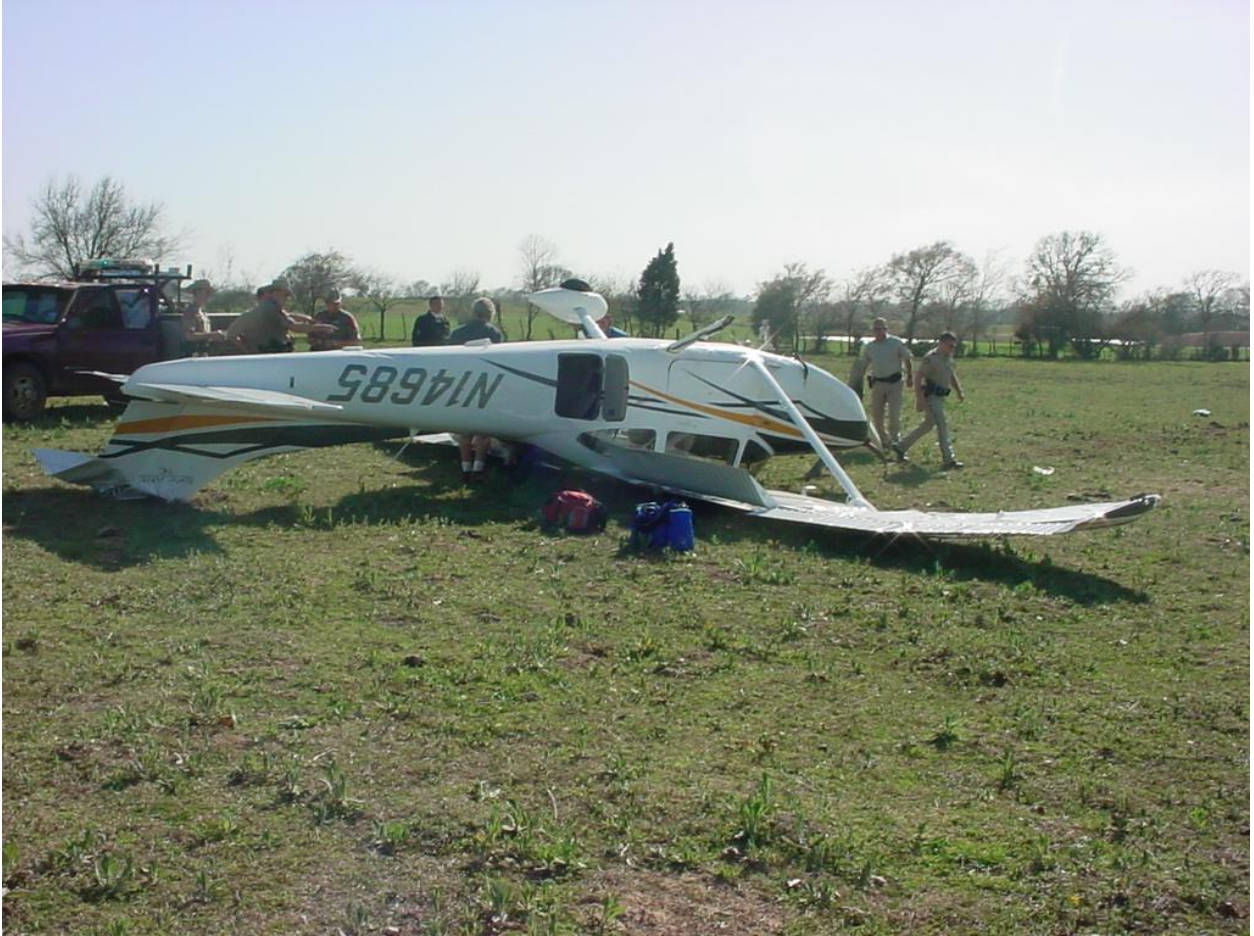
Figure 2: A photograph showing the left side of Cessna T182T, N14685, which crashed in Athens, Texas (DFW07LA078).

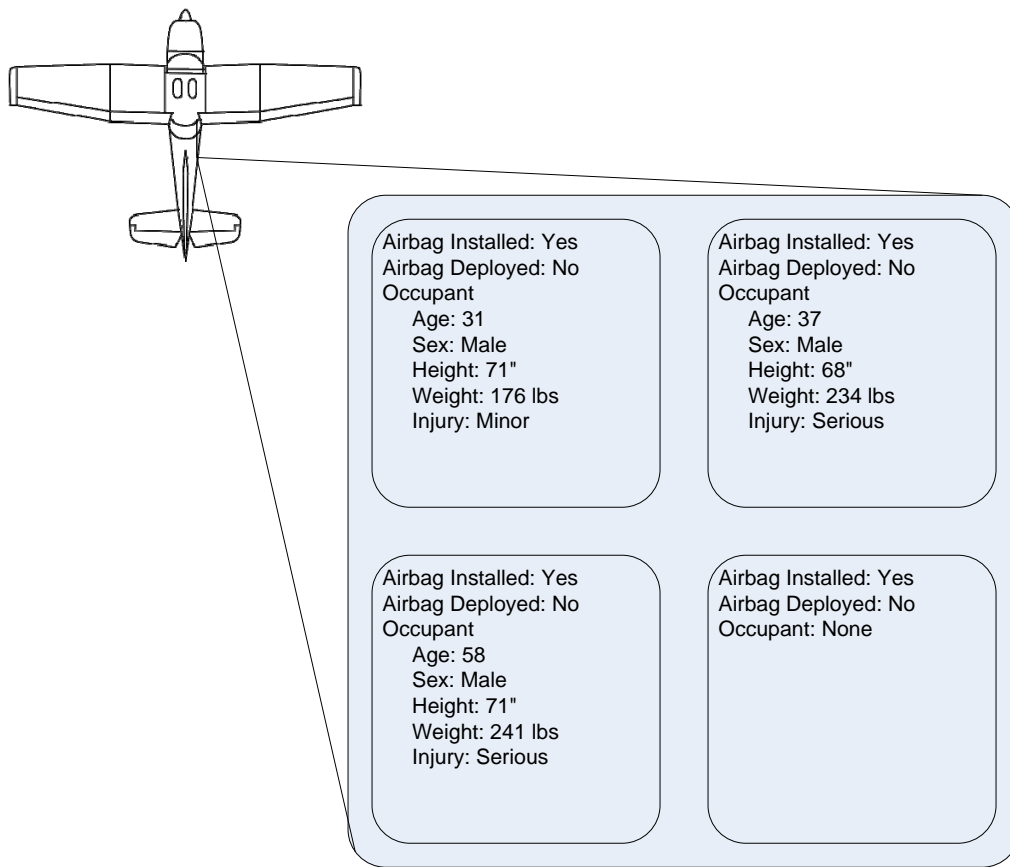
A summary of occupant demographics is depicted in Figure 3. The front right seat occupant (pilot) was 5 feet, 8 inches tall, weighed 234 pounds, and was 37 years old. He sustained three compression vertebral fractures near the base of his neck (C-7, T-1, and T-2). He also had a laceration on his head that did not require stitches. The occupant, who also reported that he had previously been employed as a paramedic, believed that his neck injury occurred as a result of his head hitting the ceiling of the airplane during the crash, and he reported that after the crash he was hanging from the seatbelt and that the vertebral fractures affected sensation in his arm.

Figure 3: A diagram depicting a summary of seat and occupant information for the Cessna T182T.
